# PRECAUTIONARY CALL FOR RETROFITTING OF SCREW GATE D-RING BOLTS

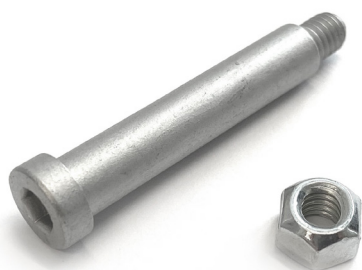
A ring was found on a RADIALIS PRO harness in a high ropes course with the thread broken off just behind the nut. In a metallurgical assessment of the bolts, it was found that there were variations in the coating of the bolts, which can lead to hydrogen embrittlement and the bolts snapping in individual cases.

EDELRID calls on the owners of the screw gate D-ring bolts to replace them immediately. The quantity of bolts required can be requested free of charge by using the [ORDER FORM](#).

Owners of affected products are urged to withdraw them from use immediately. The required quantity of bolts, as well as the designation of the affected product with batch number, must be reported to EDELRID. Then the bolts on the listed products will be replaced with the new bolts supplied.
